## Shaking Table Test on High-Rise Steel Building: Response Reduction by Retrofit with Dampers and Countermeasures for Nonstructural Components in Rooms

Experimental specimen for a 21-story high-rise building

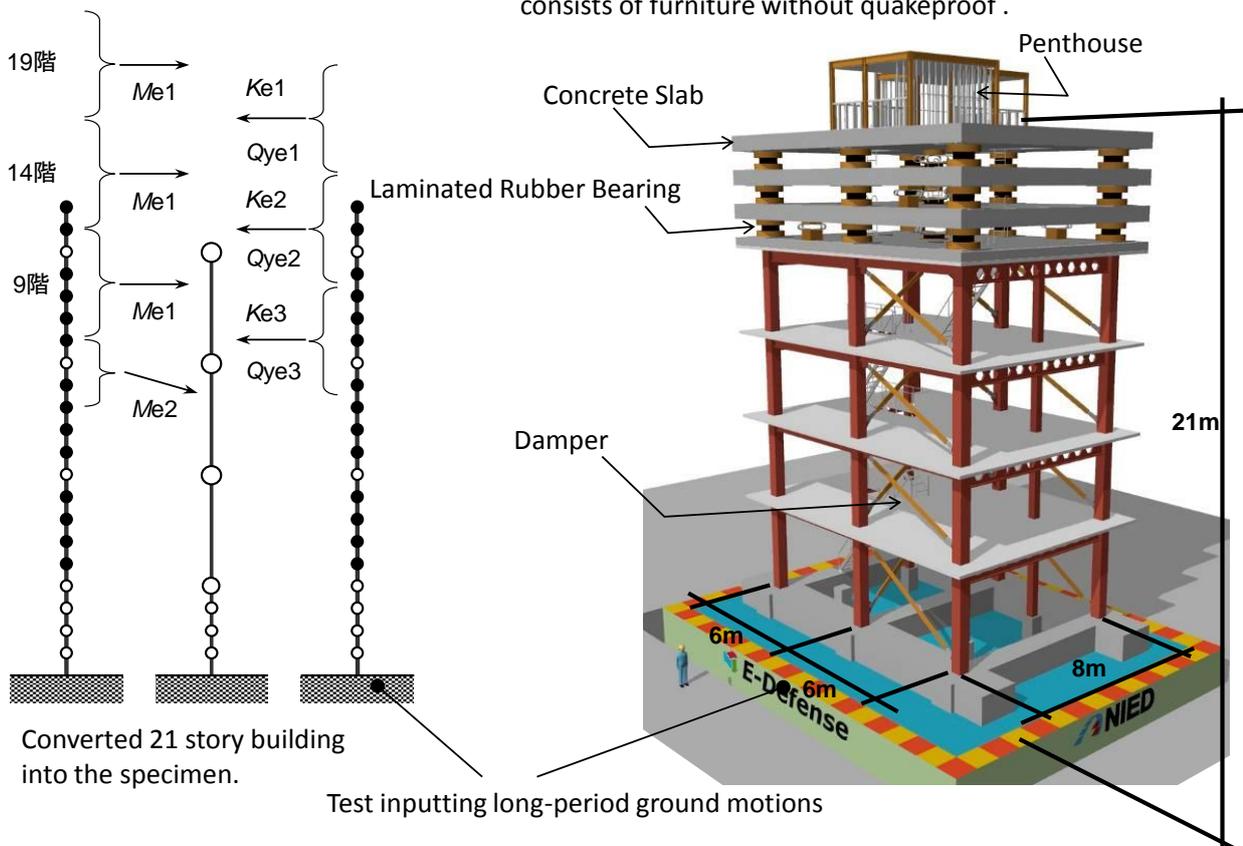
A four-story steel frame structure was prepared as the test frame, and concrete slabs and laminated rubber bearings were placed on it as the substitute layers. Dampers were incorporated in the test frame. In the test, response of 19<sup>th</sup> floor appears at the roof of the test specimen. A pair of penthouses were set including furniture to study the damage of rooms.

(b) Almost the same layouts were adopted in a pair of penthouses for each kind of room. One consists of furniture with quakeproof countermeasures, and the other consists of furniture without quakeproof.

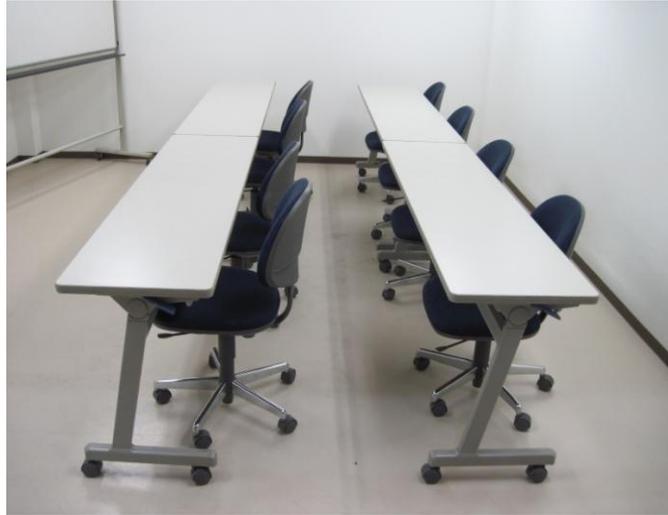
## Office/Meeting Room

In meeting rooms, furniture tends to be wheeled in order to change layout depending on the purpose of meetings.

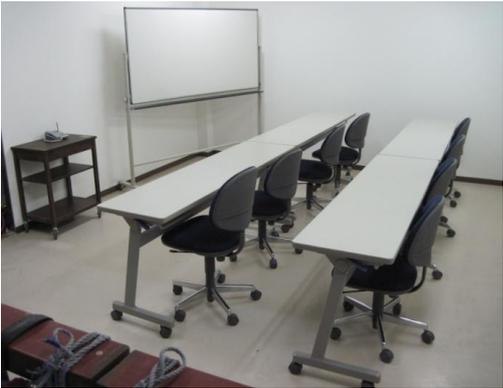
<p data-bbox="108 1417 707 1485">The tables, chairs and board, with wheels were left unlocked and a telephone was left as it was.</p>

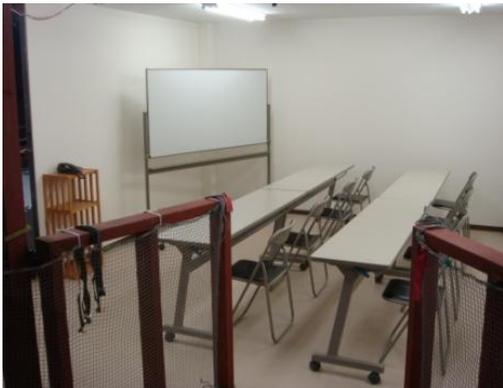
<p data-bbox="826 1417 1461 1556">The wheels were locked to stop wheeling. The chairs were exchanged to folding chairs without wheels. The telephone and the stand were fixed with sticky quakeproof mats.</p>

<p>4 pieces of sticky quakeproof mats (two of 3cm square and two of 2cm square) were used to fix the telephone stand on the floor and to fix the telephone on the stand. The wheels of the tables were locked.</p>

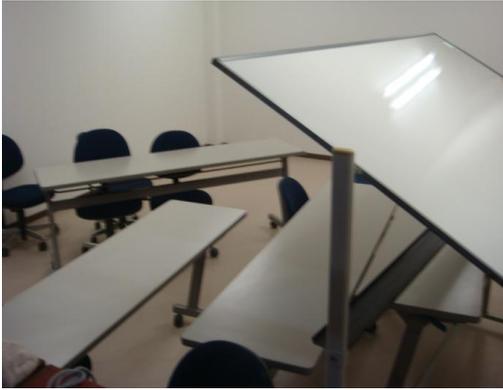
The furniture kept moving for long time and hit on walls repeatedly insomuch as to make holes on them.

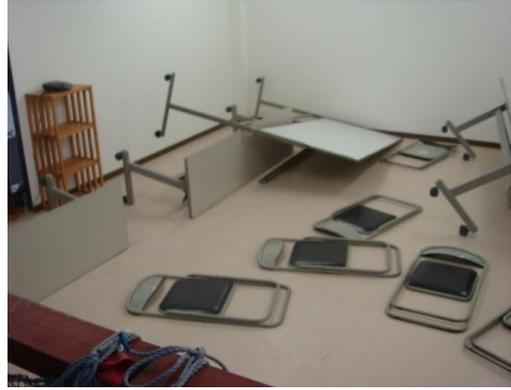
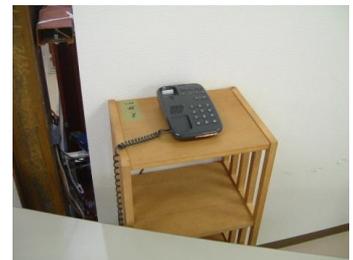
The tables, chairs and board with rocked wheels fell down. But they did not slide or move around. The telephone and the telephone stand did not move at all.

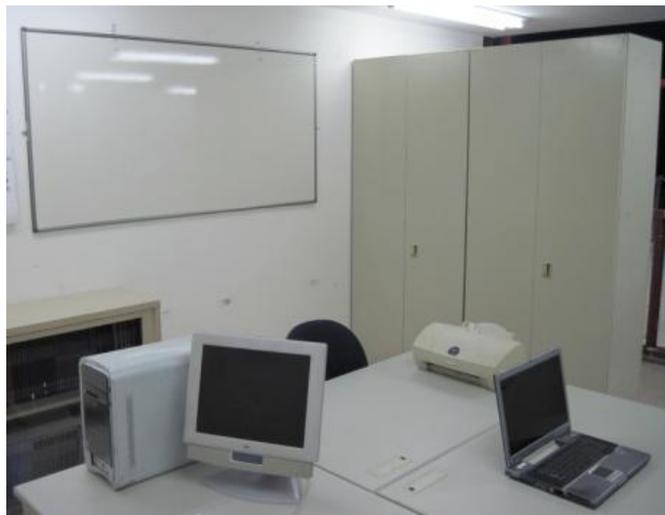
## Office / Workspace

Behaviors of furniture in a workspace of office was examined. Almost the same layouts were adopted a pair of rooms, and effects of countermeasures were verified. In each room, three desks, three chairs with wheels, five steel bookshelves, a steel cabinet and a copy machine were set up. A desktop personal computer, a laptop and a printer were placed on the desks. Two bookshelves were placed to play roles of partition and blindfold so that a trend of ordinary office rooms was reproduced.

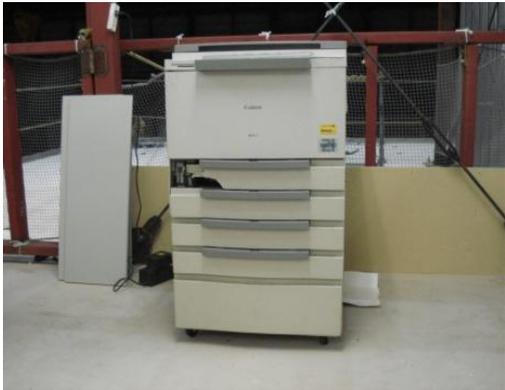
<p style="text-align: center;">The casters were unlocked.</p>

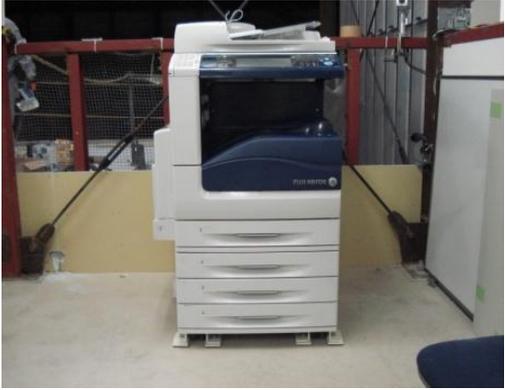
<p style="text-align: center;">The casters were fixed by special stoppers.</p>

<p>Sticky quakeproof mats were used to fix metal fixers on the floor. Four fixer were plugged to each casters for restraining the movement of casters.</p>

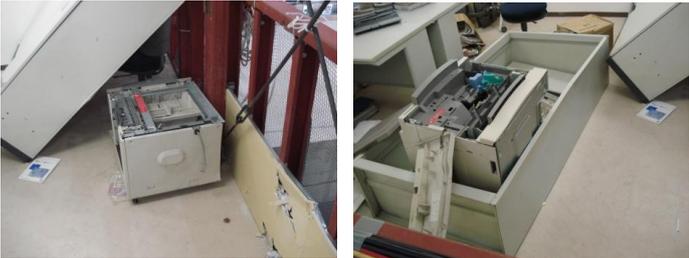
<p>The copy machine kept running and hitting on things around for long time, and finally broke into 2 pieces by cumulative impulsions.</p>

<p>The copy machine fixed by a special tool didn't move neither fell.</p>

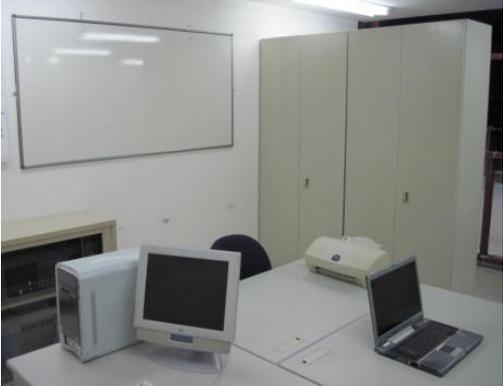
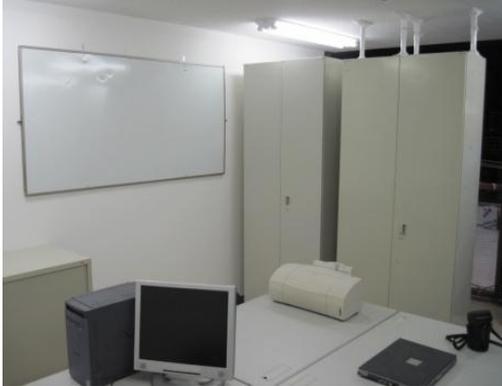
<p>Supposing to be used as a partition, bookshelves were set apart from the wall so that their front and back become open space.</p>

<p>Base of a shelf was clamped by fixers utilizing sticky quakeproof mats.</p>

<p>Four strut poles were set on the top of a shelf.</p>

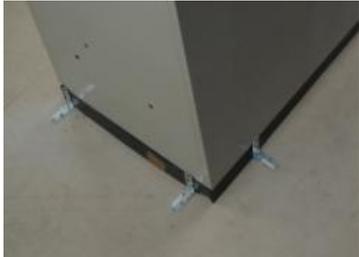
<p>Base of a shelf was clamped by bolted L-shape steel clasps.</p>
---	--	---

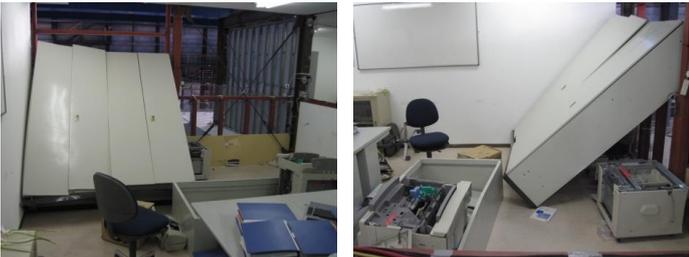
<p>The shelves fell down to backward open space at the beginning of the experiment.</p>

<p>The shelves showed effects of various countermeasures, and both of them didn't move or fall.</p>

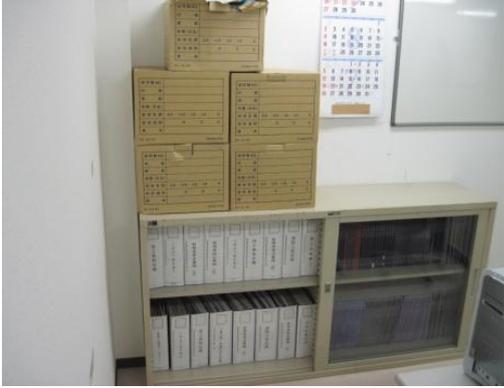
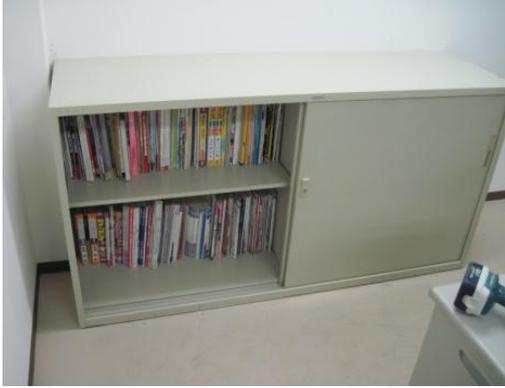
<p>Five cartons full with papers inside were placed on the top and folders were set inside of the low cabinet.</p>	<p>Five cartons full with papers inside were placed on the top and folders were set inside of the low cabinet.</p>

<p>Sticky quakeproof mats, 2x10cm, were used at four corners and the middle. The sliding doors were locked.</p>

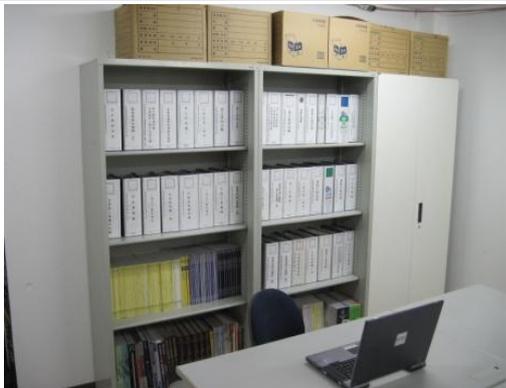
<p>Cartons full with papers inside were set on top of the shelves. Books and files were put inside the shelves.</p>

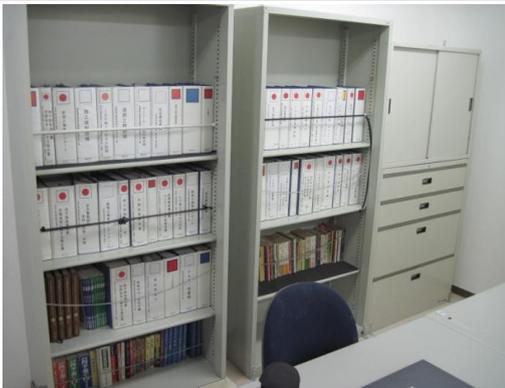
<p>Nothing was left on top of the shelves, books and files were set lower part with extra space.</p>

<p>The left bookshelf; sticky quakeproof mats were used for fixers to clamp base to the floor. The middle and right shelves; The shelves were bolted to the wall at the top and bolted to the floor at the base by using L-shape steel claps. Poles, rubber bands and chains were laterally set in the width direction of open shelves.</p>

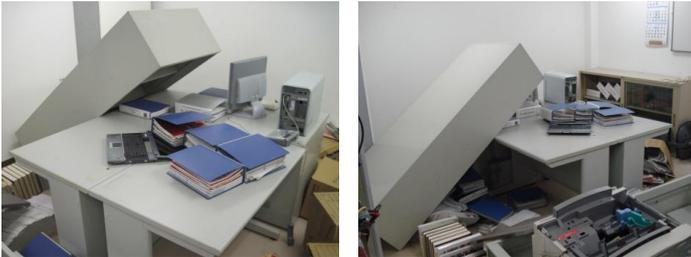
<p>All the book shelves fell down and clashed against desks. Papers and files came out and scattered apart.</p>

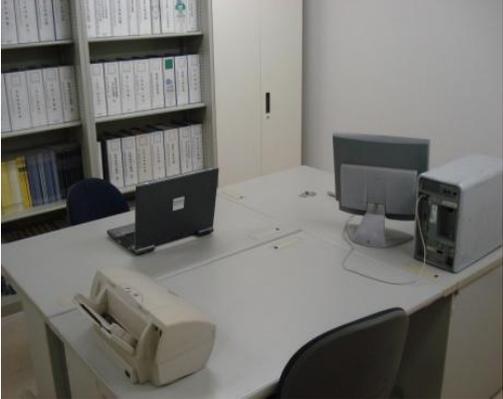
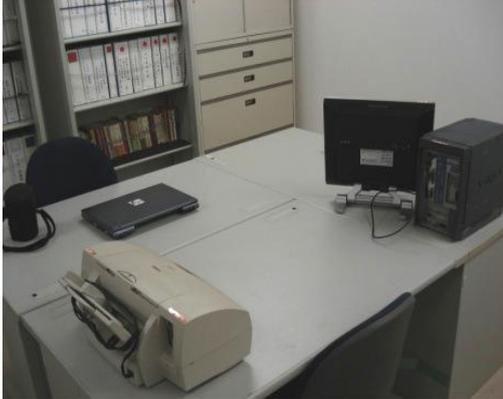
A photograph of the same office desk, showing the laptop, desktop monitor, and printer. The setup is similar to the 'Without countermeasures' photo.
<p>A desk top PC, a lap top PC and a printer were set on desks.</p>

A photograph showing the underside of a printer with a blue sticky mat attached to the bottom.
<p>Sticky quakeproof mats were set to bottoms of the desk top PC, the lap top PC and the printer, everything on the desks. And also quakeproof mats were set to the underneath of all desk legs.</p>

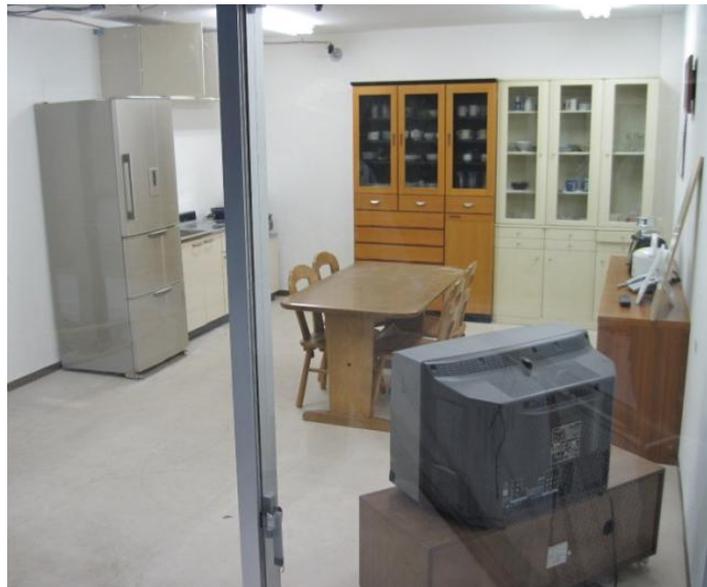
# House

For experiment of a house, places where persons gather, such as dining, kitchen and living room were reproduced to study the behaviors of the furniture and household articles.

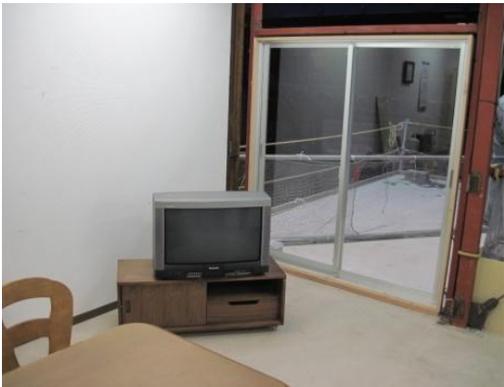
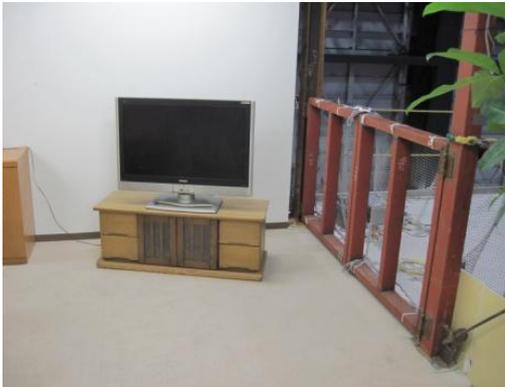
<p>A 29-inch tube TV was set on a TV stand with casters. The casters were unlocked.</p>	<p>A 37 inches liquid crystal television was set on a TV stand without casters.</p>

<p>Sticky quakeproof mats were applied to the underneath of TV stand and the underneath of liquid crystal television.</p>

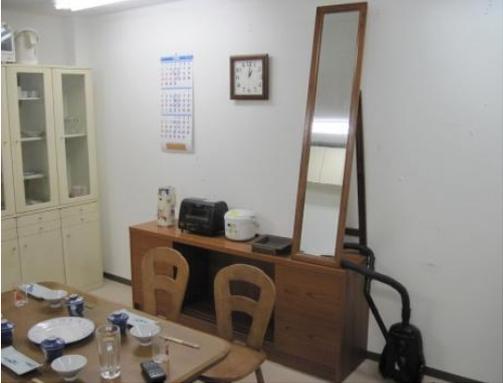
<p data-bbox="118 1216 759 1283">An electric pot, a toaster oven, a rice cooker, a telephone and a stand mirror were set on a low board.</p>

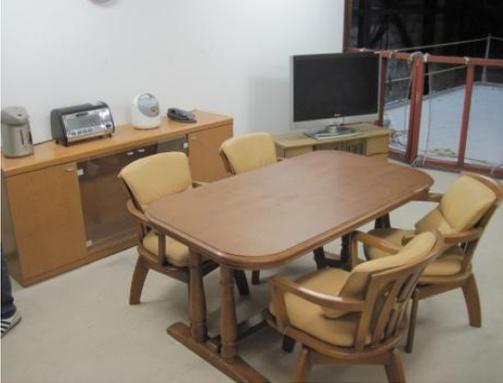
<p data-bbox="815 1216 1422 1317">Similar things as the case of "without a countermeasure" were set on a low board, except a stand mirror.</p>

<p data-bbox="188 1675 1281 1709">Sticky quakeproof mats were set directly to the bottom of things and low board itself as well.</p>

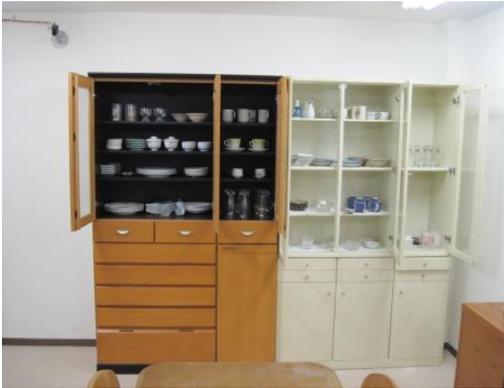
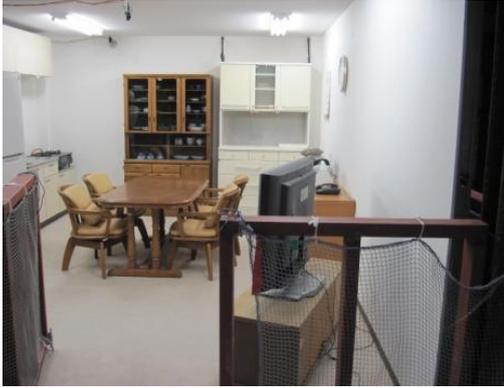
<p>Two sets of separate-type commonly used cupboards were placed along the wall. Dinnerware was stored inside.</p>	<p>Two sets of separate-type cupboards were placed along the wall. Earthquake countermeasures were taken for them.</p>

<p>Commercially-available products were adopted preventing spring out of hinged doors and sliding drawers. The left cupboard; sticky quakeproof mats paired with L-shaped steel clasps were used to clamp the bottom. And the same mats were incorporated between top and bottom parts. The right cupboard; the top part was diagonally pulled up to the wall with resistant belts, and the bottom was bolted to the floor with L-shaped steel clasps. The top and bottom parts were bolted together with steel clasps.</p>

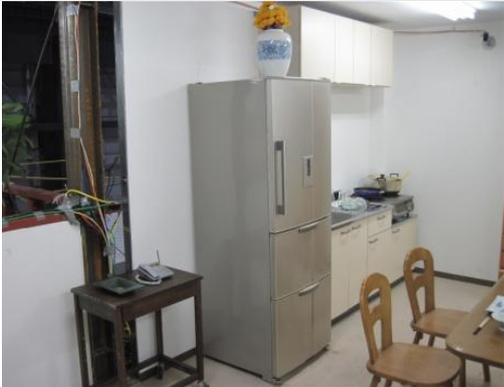
<p>A common refrigerator has casters on its back bottom for easy-moving. The same type of refrigerator was set, whose casters had no lock function.</p>

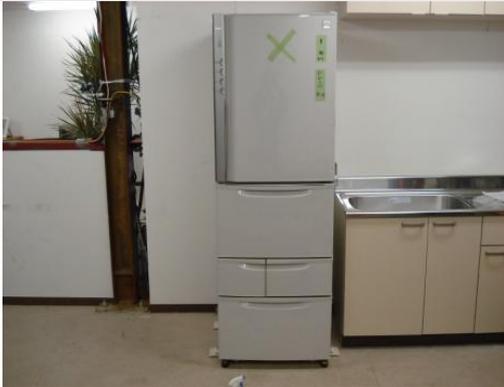
<p>A common refrigerator with casters, which have no lock function, was fixed with additional stopper.</p>

<p>The sticky quakeproof mats coupled with L-shaped steel clasps were incorporated at bottom of the refrigerator. The stopper belts were applied to all the hinged doors and the sliding drawers to prevent springing out.</p>

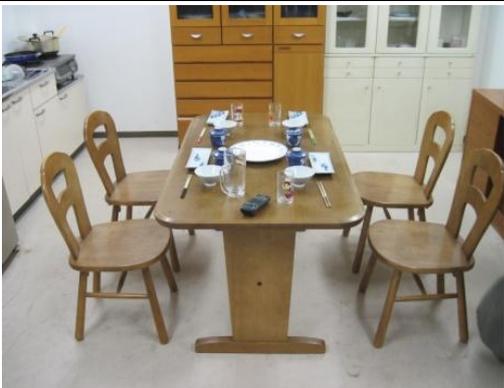
<p data-bbox="118 763 778 860">A dining table and chairs were set reproducing COF 01.-0.3, supposing condition between wood floor and wood furniture.</p>

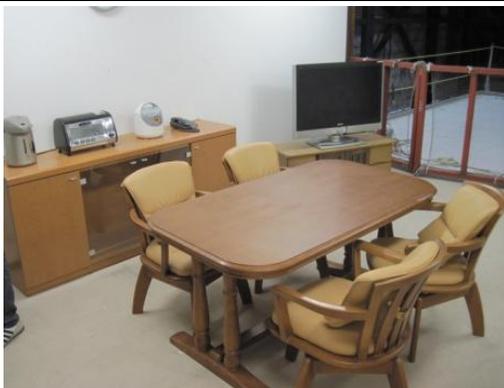
<p data-bbox="868 763 1437 860">A dining table was specially treated to fix on the floor. Chairs having adjunctive mats at the bottoms of their feet were set.</p>

<p data-bbox="124 1211 1023 1279">Sticky quakeproof mats were incorporated to the bottom of the dining table. Sixteen pieces of 2cm square mats were used.</p>

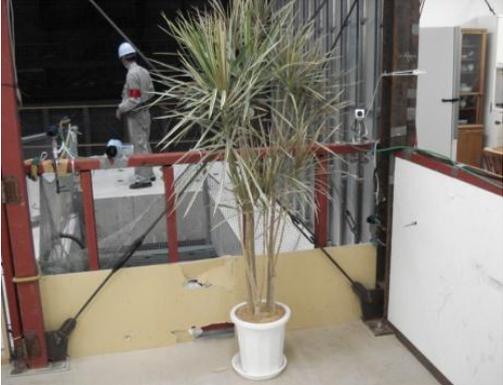
<p data-bbox="197 757 681 790">A tall house plant was set with a saucer.</p>

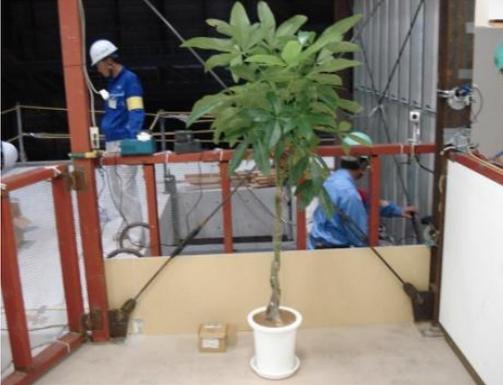
<p data-bbox="1002 757 1308 790">A similar tall house plant.</p>

<p data-bbox="156 1176 1257 1209">The sticky quakeproof mats were applied directly on the flower pot saucer and the flower pot.</p>
